**D SERIES CONTROLLER  
TROUBLESHOOTING AND  
COMPONENT REPLACEMENT  
MPVDCONTV113E-3**

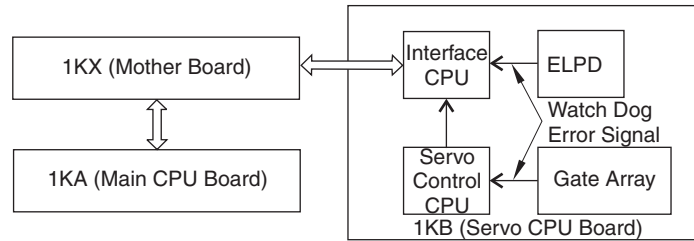
**ERROR CODE D1004** [ARM CTRL BOARD] watch dog error of servo control software.

The watch dog circuit on the 1KA board or 1KB board has detected a software problem. This is caused by a defective 1KA main CPU board or 1KB servo CPU board or a problem with the servo software.

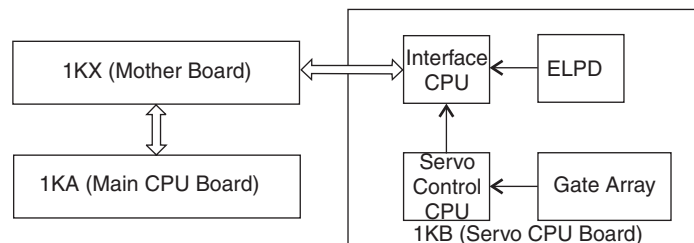
**ERROR CODE D1005** Servo board command error. (xx)

Servo software returned an error code, other than a servo system error, to the AS software after receiving an unrecognized command from the 1KA board.

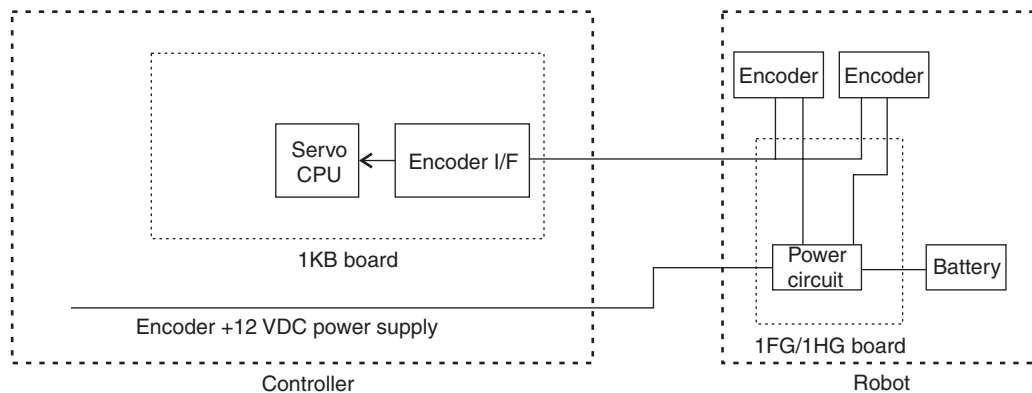
### ERROR CODE E1030 Encoder data abnormal. (Jt XX)

When control power is switched ON, the current encoder value is compared to the stored encoder value when the power is turned OFF. If the difference is more than the value set in AUX 0504 Encoder Error Range, or by the ENCCCHK\_DATA command, this error occurs.

1. Value set in AUX 0504 is too small.
2. Backup battery failure due to disconnection or discharged battery (+3.3 VDC or less).
3. Control power is turned off during robot motion by an abnormal power supply, etc., causing the robot to stop in a position other than the last position stored in the AS software.
4. Motor replacement/encoder replacement (zeroing must be performed).
5. Robot arm or motor operated by force when control power is off.
6. Controller was initialized (this error occurs for all axes).
7. Servo spot weld gun.
  - Loose connection at tool changer.
  - Defective tool changer harness.

- ⇒ Ensure the value set in AUX 0504 is correct.
- ⇒ Data may have been lost due to backup battery. See error W1013. Replace the battery. There is a possibility that internal encoder data may be lost. Check the robot zeroing.
- ⇒ Check connections at tool changer, clean connections, replace harness as necessary.
- ⇒ Check each harness for short circuit and repair, or replace, as necessary.
- ⇒ Replace the encoder, the 1KB board or the 1FG/1HG encoder battery backup board as necessary.
- ⇒ After repair is complete, confirm correct program playback in check mode before running program in repeat mode.

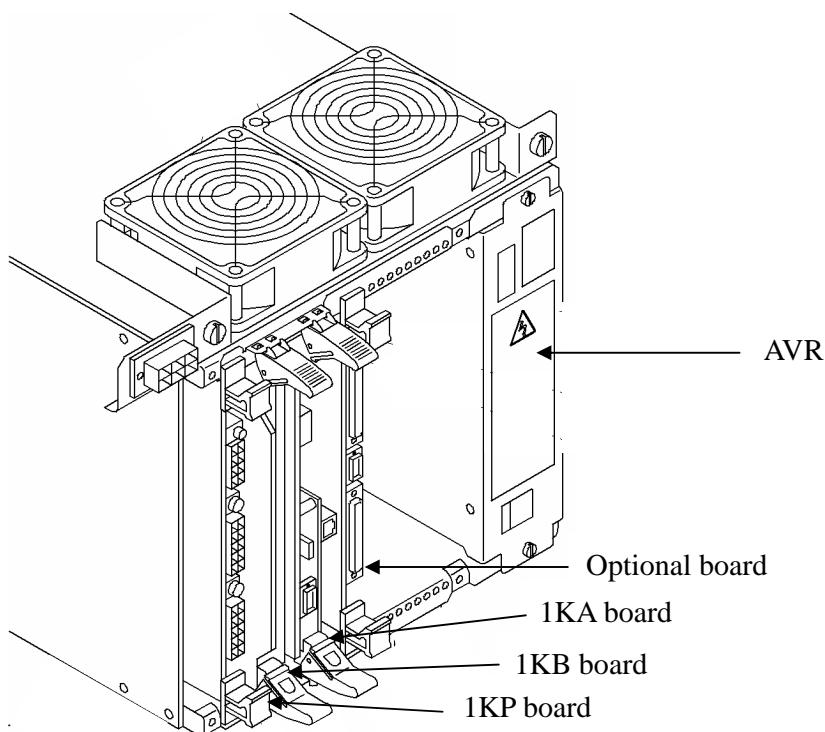
In the card rack of D3x controller, the 1KP board (power sequence board), 1KB board (arm control board), 1KA board (user I/F board), optional board, and the AVR are housed from the left as shown below. For D7x controller, the 1NR board (brake control board) is housed in the leftmost of the card rack.

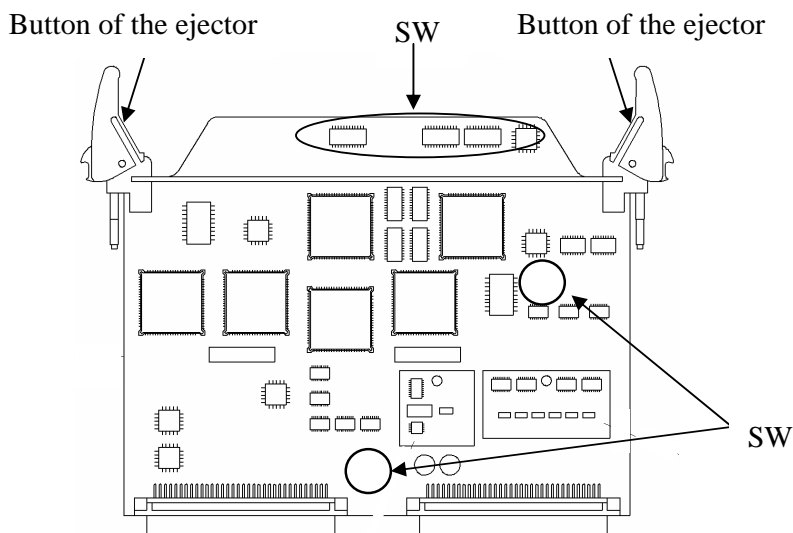
Overview of the 1KB board

1. Turn OFF the control power.
2. Press the red button on the ejector of the 1KB board to release the lock, and pull out the 1KB from the card rack by extending the ejector up and down.
3. Confirm that settings for SW1 to SW8 and SW10 on the new 1KB are the same as before board replacement. Then, insert the new 1KB to the card rack and set it in the mother board.

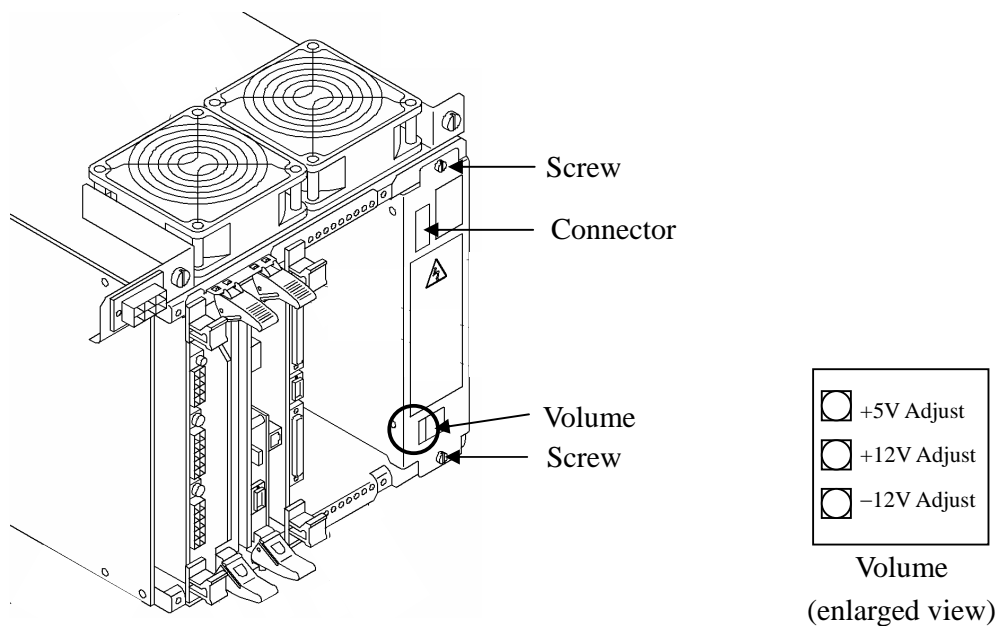
Overview of the AVR

No.	Color	Standard	Allowable range	If the voltage is out of allowable range,
TP1	White	+24.0 V	+23.9 V ~ +24.7 V	Replace the AVR.

7. If there is no abnormality in the controller after checking voltage, paint lock each adjust volume of the AVR.

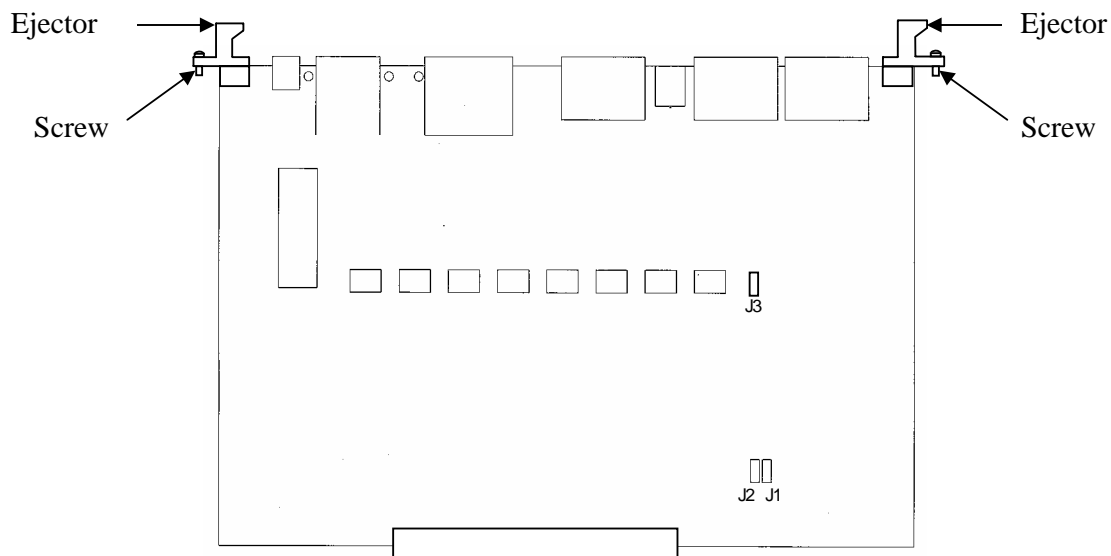
Overview of the 1NR board

1. Turn OFF the control power.
2. Loosen the screws on top and bottom of the 1NR board, and pull out the 1NR from the card rack by holding the ejectors at both ends of the board. If wired to the front connector, remove the connector first.
3. Confirm that settings for J1, J2 and J3 on the new 1NR are the same as before board replacement. Then, insert the new 1NR to the card rack and set it in the mother board.
4. Fasten the screws on top and bottom of the 1NR.

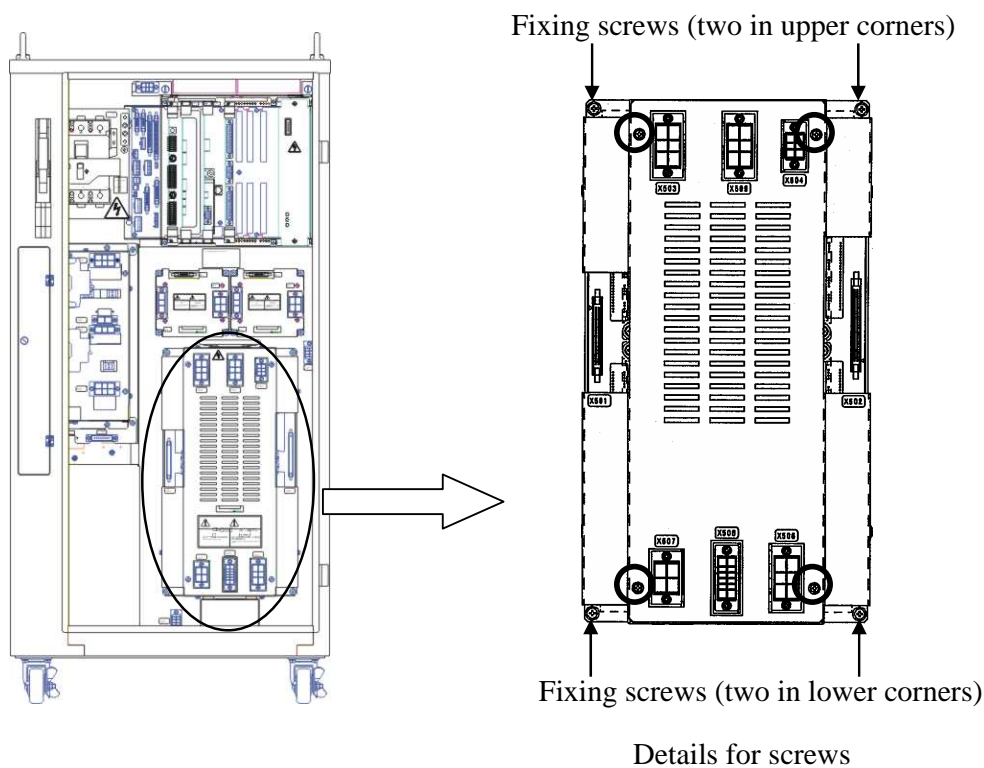
1. Remove all connectors connected to the power block unit.
2. Loosen the four screws fixing the power block unit to the controller so that the power block unit can be removed from the controller. (These screws are not removed from the power block unit.)
3. To remove the power block unit, pull it out by sliding on the fulcrum. To be safe, hold the handle on top with one hand.
4. Place the new unit on the fulcrum, and set it in by holding the handle on top with one hand. Then, attach it to the controller by fastening the four screws correctly.
5. Restore the connectors removed in step 1.

○: Screws on the front of power block unit  
(Do not touch any of these screws.)

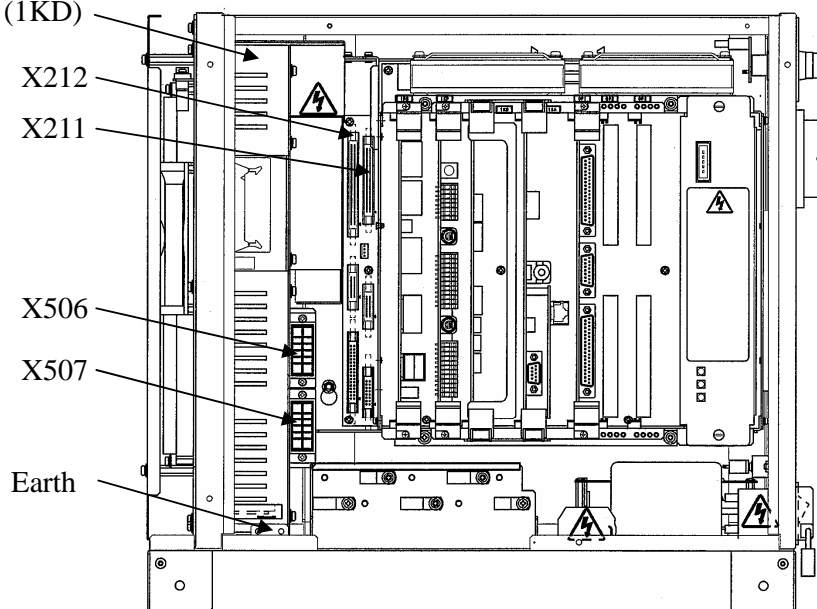
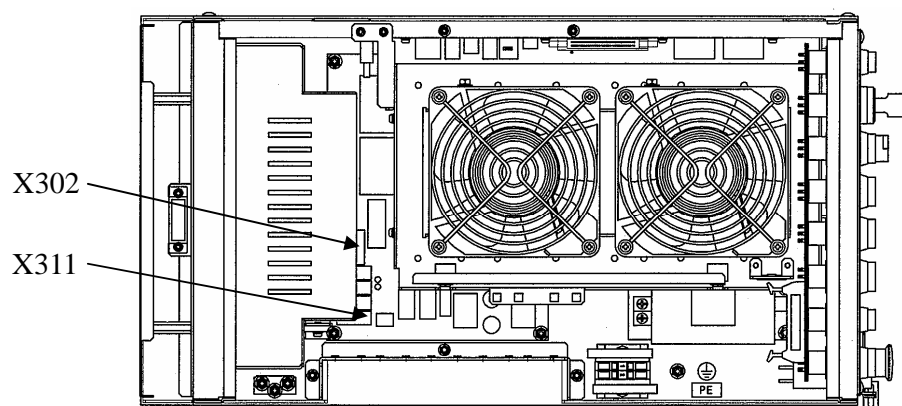
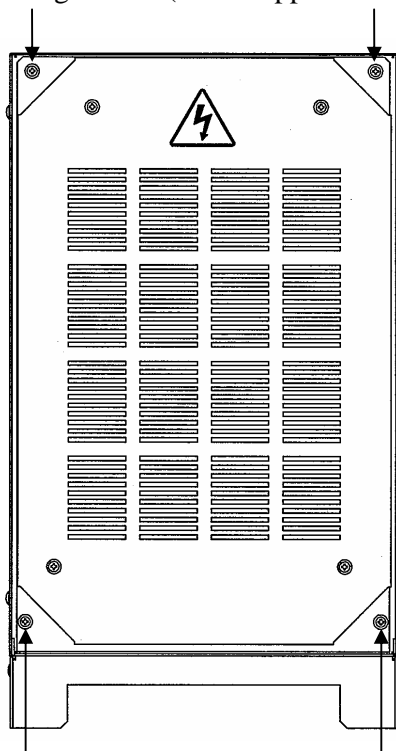
Power block unit (1KD)

1. Remove the controller cover.
2. Remove the connectors X506 and X507 connected to the power block unit.
3. Remove the screw fixing the earth wired from the power block unit.
4. Remove the four screws fixing the power block unit to the controller.
5. Pull out the power block unit by sliding backward on the fulcrum.
6. Remove the connectors X302 and X311.
7. Remove the connectors X211 and X212.
8. Remove the power block unit.
9. Attach the new unit to the controller in reverse order of removal.

Fixing screws (two in upper corners)

Fixing screws (two in lower corners)

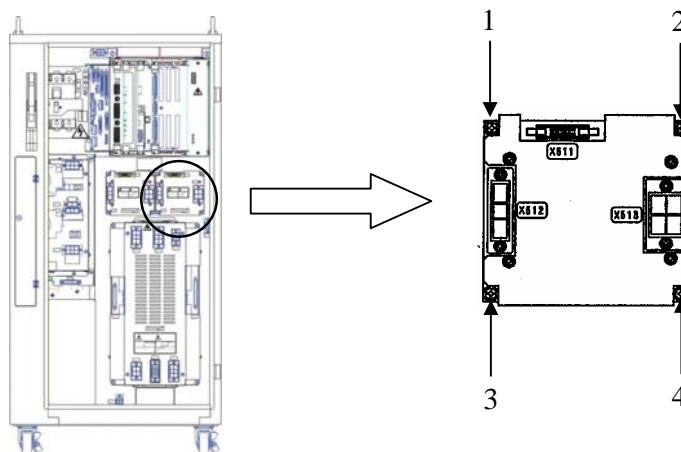
1. Remove all connectors connected to the power block unit.
2. Loosen the four screws fixing the power block unit to the controller (1 to 4 in figure below) so that the power block unit can be removed from the controller. (These screws are not removed from the power block unit.)
3. Remove the power block unit.
4. Attach the new unit to the controller by fastening the four screws removed in step 2 correctly.
5. Restore the connectors removed in step 1.

The replacement procedure for the 1KR is same as that for the 1KL.

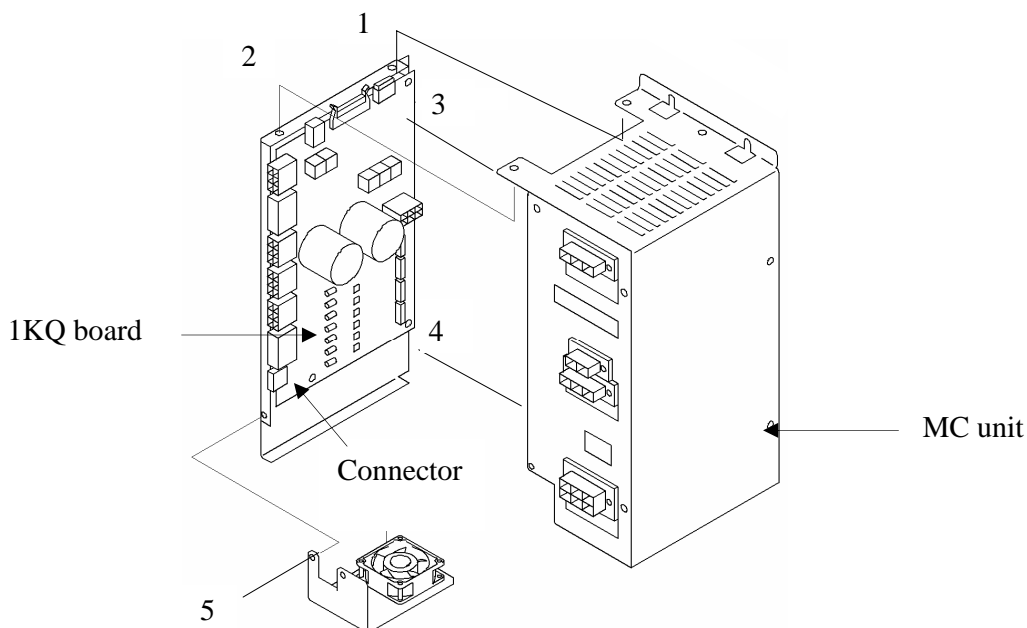
1. Remove the MC unit. For details, refer to 2.4.1 MC Unit.
2. Remove the four screws fixing the 1KQ board assy to the MC unit (1 to 4 in figure below), the one screw fixing the fan unit of the MC unit (5 in figure below), and the connector for the fan. Then, pull out the 1KQ board assy.

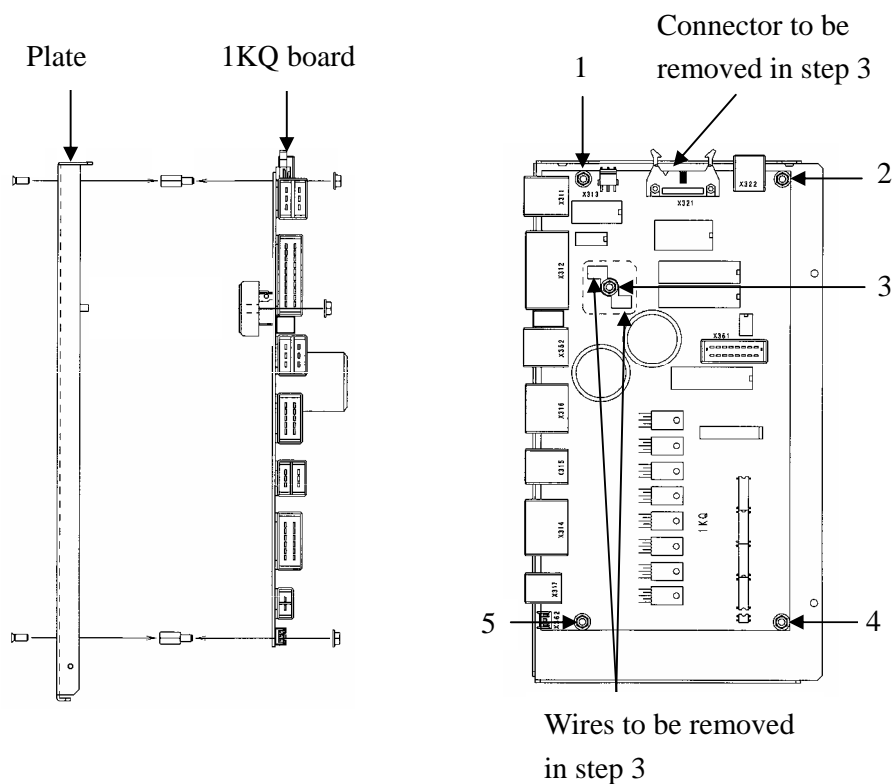
4. Loosen the five nuts fixing the 1KQ to the plate (1 to 5 in figure below), and remove the 1KQ.
5. Attach the new 1KQ to the plate with the five nuts removed in step 4.
6. Restore the connector and two wires removed in step 3 to the assy assembled in step 5.
7. Refasten the screws and connect the connector removed in step 2.
8. Attach the MC unit to the controller. For details, refer to 2.4.1 MC Unit.

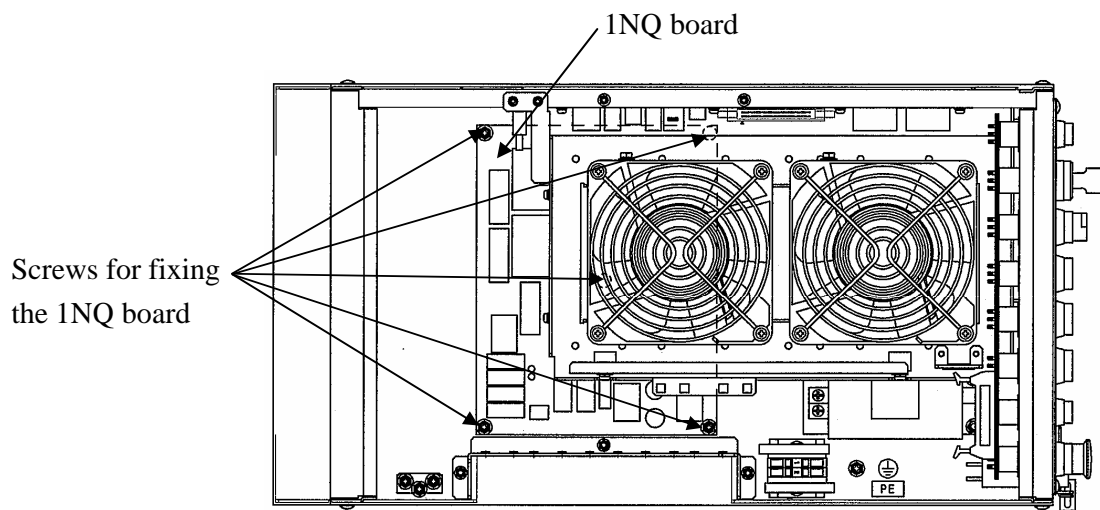
## 2.5 REPLACEMENT PROCEDURE FOR 1NQ BOARD (FOR D7X CONTROLLER)

This section describes the replacement procedure for the 1NQ board (power circuit board)

1. Turn OFF the control power.
2. Remove the power block unit. (For the procedure, see 2.3.3 1KD Power Block Unit (for D7x Controller).)
3. Remove the 1NR, 1KP, 1KB, and 1KA boards in the card rack.
4. Remove all connectors connected to the 1NQ board.
5. Remove the five screws fixing the 1NQ board.
6. Remove the 1NQ board from back side.
7. Attach the new 1NQ board by fastening the five screws.
8. Restore the connectors removed in step 4.
9. Restore the boards removed in step 3.
10. Restore the power block unit to the controller.

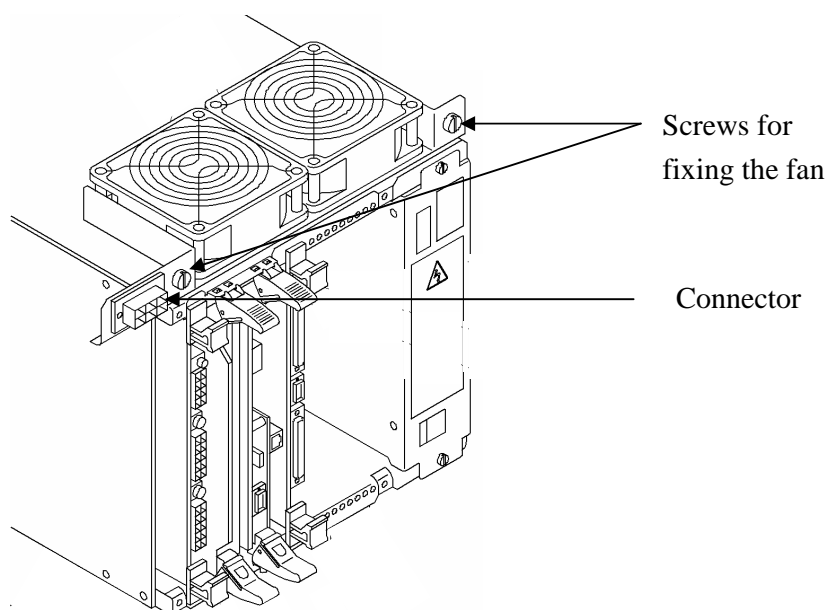
### 2.6.1 FAN FOR CARD RACK

1. Turn OFF the control power.
2. Remove the connector connecting the fan to the card rack. Then, loosen and remove the two screws fixing the fan unit.
3. Remove the power line and the earth wire connected to the fan. Loosen the four screws fixing the fan, and then remove the fan.
4. Attach the new fan with the four screws, and restore the power line and earth wire removed in step 3. Be sure to reattach the fan correctly; wind blows top to down.
5. Attach the fan unit to the top of the card rack, and fasten it with the two screws.
6. Restore the connector removed in step 2.

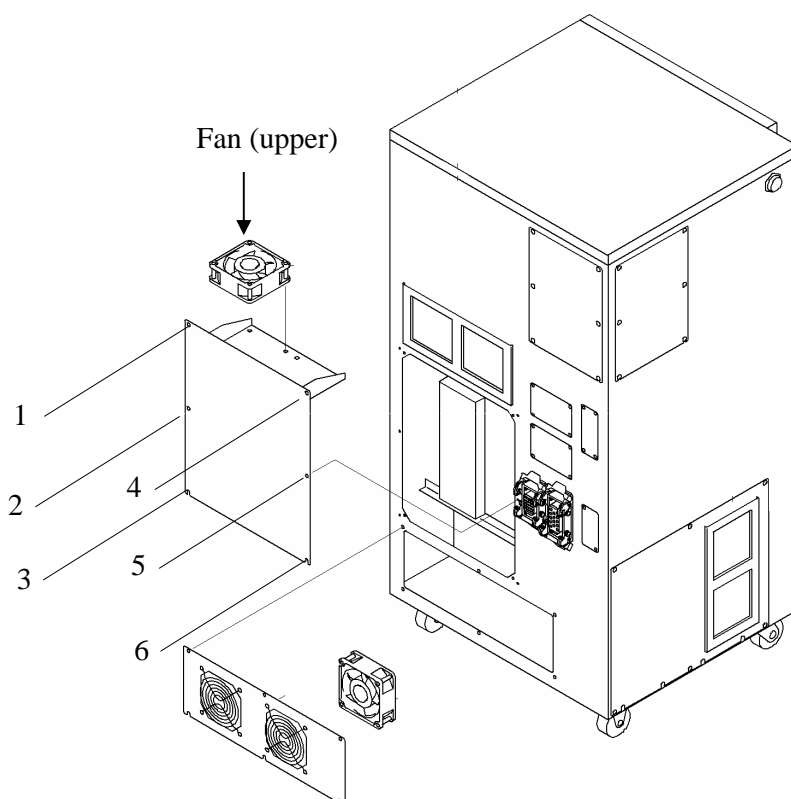
### 2.6.2.1 UPPER FAN ON BACK OF CONTROLLER

1. Turn OFF the control power.
2. Remove the six screws fixing the plate on the controller back (1 to 6 in figure below).
3. Pull out the plate, remove the connector connected to the controller, then remove the plate.
4. Remove the power line and the earth wire connected to the fan. Loosen and remove the four screws fixing the fan, and then remove the fan.
5. Attach the new fan to the plate with the four screws, and restore the power line and earth wire removed in step 4. Be sure to reattach the fan correctly; wind blows top to down.
6. Restore the connector removed in step 3, and reattach the plate with the six screws.

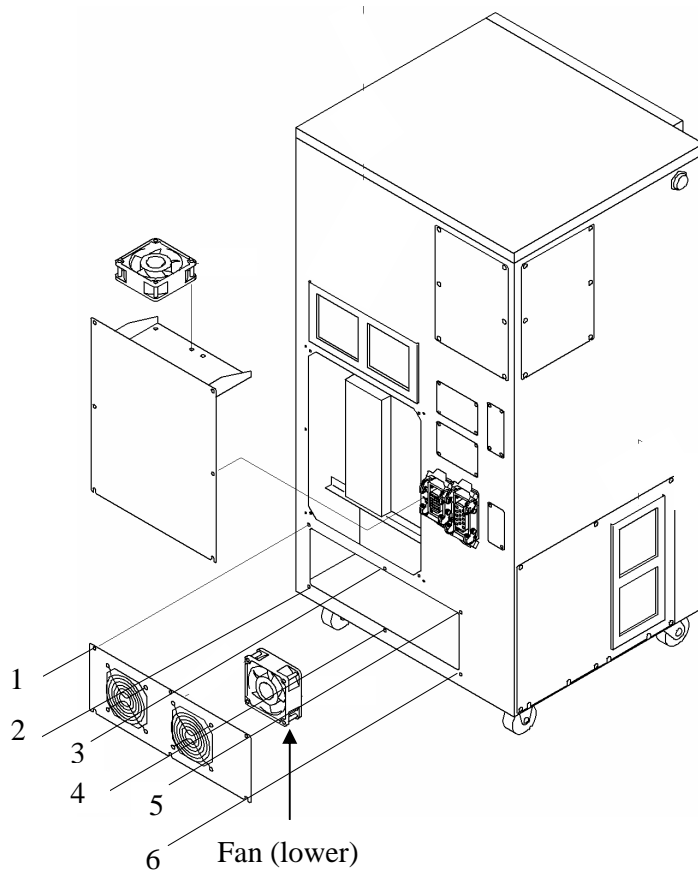
### 2.6.2.2 LOWER FAN ON BACK OF CONTROLLER

1. Turn OFF the control power.
2. Remove the six screws fixing the plate on the controller back.
3. Pull out the plate, remove the connector connected to the controller, and remove the plate.
4. Remove the power line and the earth wire connected to the fan. Loosen and remove the four screws fixing the fan, and then remove the fan.
5. Attach the new fan to the plate with the four screws, and restore the power line and earth wire removed in step 4. Be sure to reattach the fan correctly; wind blows from inside to outside.
6. Restore the connector removed in step 3, and reattach the plate to the controller with the six screws.

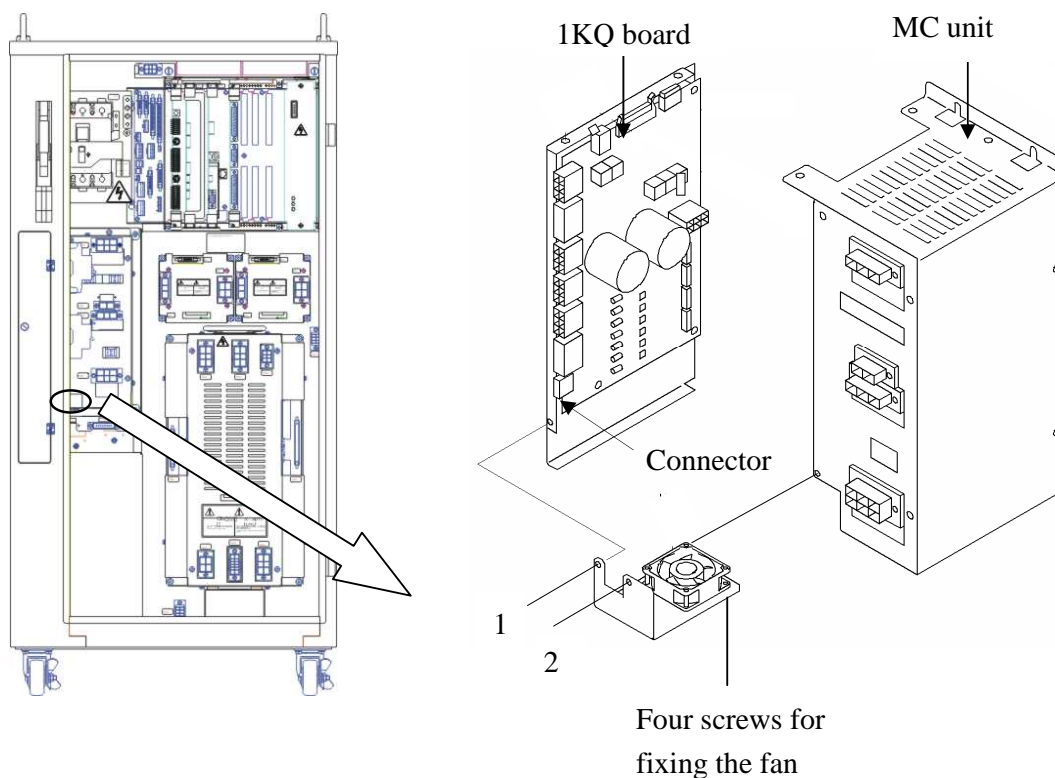
### 2.6.3 MC UNIT FAN

1. Turn OFF the control power.
2. Remove the two screws at the bottom of the MC unit (1 and 2 in figure below) and pull out the plate. Remove the connector connected to the 1KQ board and remove the fan unit.
3. Remove the four screws fixing the fan and remove the fan.
4. Attach the new fan to the plate with the four screws. Be sure to reattach the fan correctly; wind blows top to down.
5. Restore the connector removed in step 2, and attach the plate to the MC unit with the two screws.

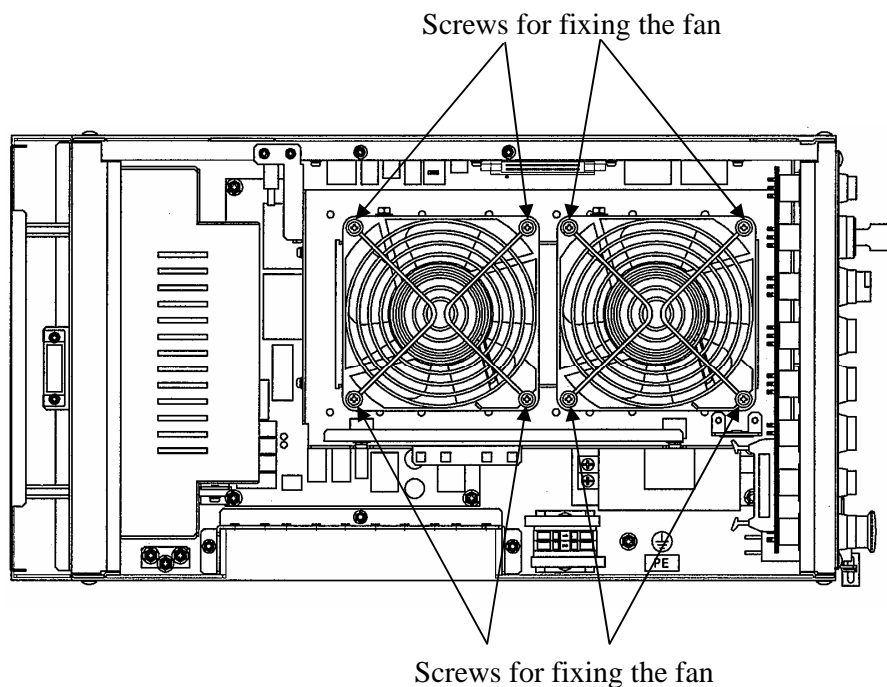
### 2.7.1 FAN FOR CARD RACK

1. Turn OFF the control power.
2. Open the controller cover.
3. Remove the four screws fixing the fan.
4. Remove the power line and the earth wire connected to the fan, and then remove the fan.
5. Restore the power line and earth wire removed in step 4 to the new fan.
6. Fix the fan with the four screws. Be sure to reattach the fan correctly; wind blows top to down.

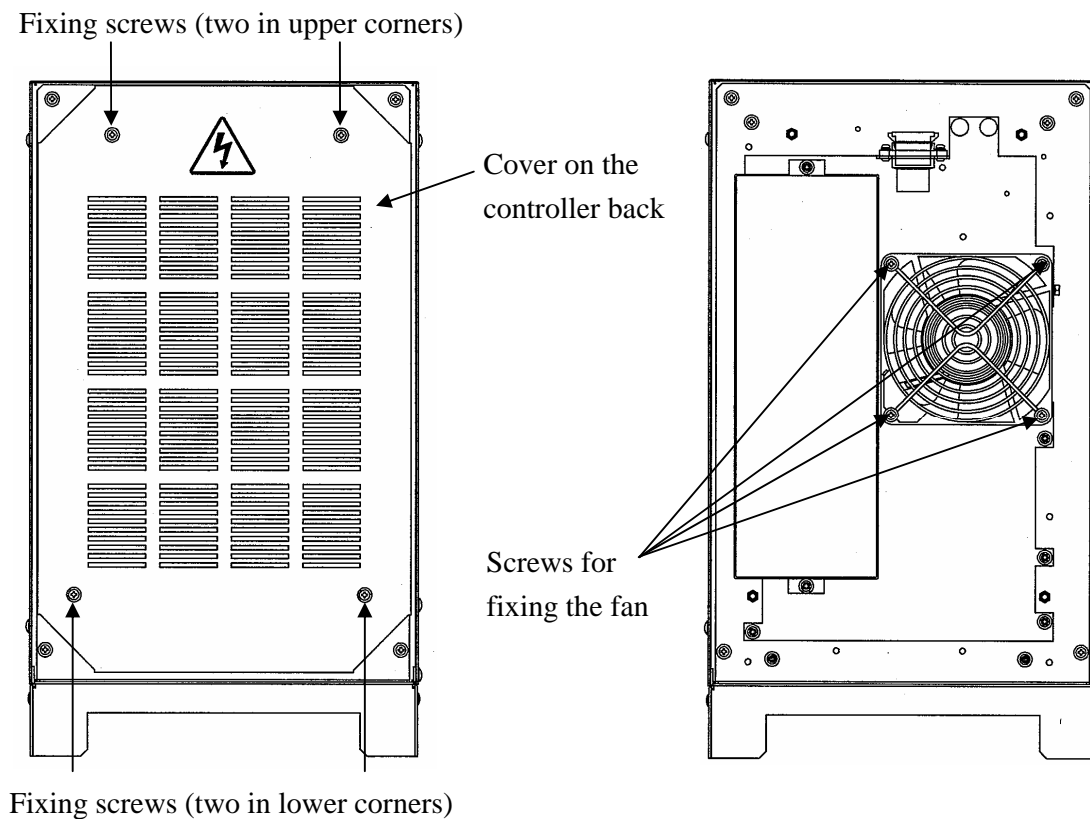
### 2.7.2 FAN FOR POWER BLOCK UNIT

1. Turn OFF the control power.
2. Remove the four screws fixing the cover on the controller back, and then remove the cover.
3. Remove the four screws fixing the fan.
4. Remove the power line and the earth wire connected to the fan, and then remove the fan.
5. Restore the power line and earth wire removed in step 4 to the new fan.
6. Fix the fan with the four screws. Be sure to reattach the fan correctly; wind blows from outside to inside.
7. Restore the cover on the controller back with the four screw.

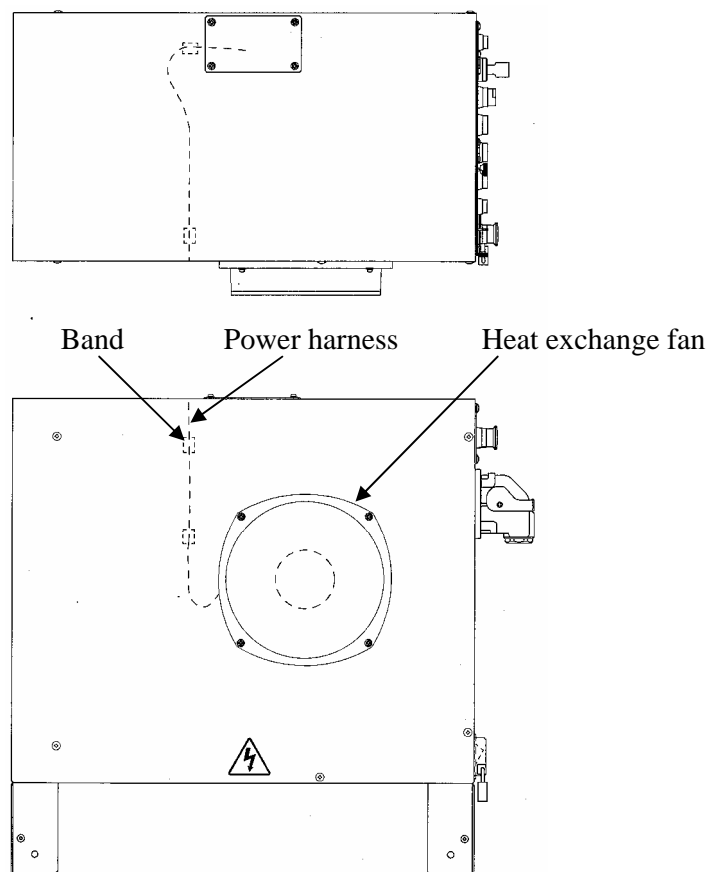
### 2.7.3 HEAT EXCHANGE FAN (FOR D71/74/77 CONTROLLER)

Heat exchange fan is installed on the left side of the controller cover.

1. Turn OFF the control power.
2. Remove the controller cover.
3. Remove the power harness from the bands which fix the harness.
4. Remove the four screws fixing the fan, and then remove the fan.
5. Attach the new fan with the four screws. Be sure to reattach the fan correctly.
6. Restore the power harness removed in step 3 with the bands.
7. Restore the controller cover.

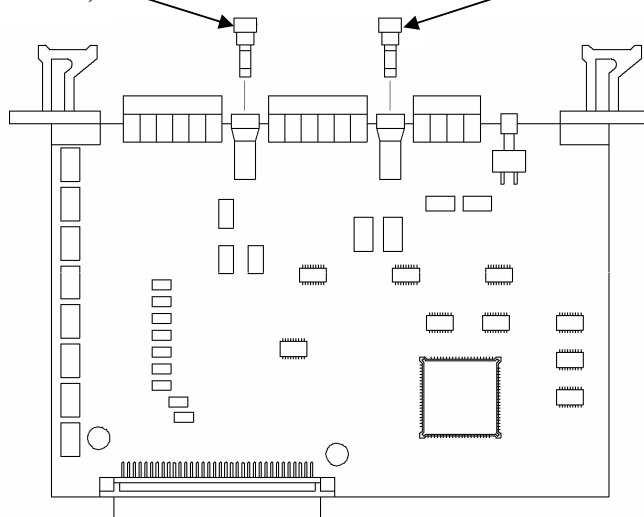
Overview of the 1KP board

1. Turn OFF the control power.
2. Push the fuse on the front of the board and turn it 90 degrees to the left. Then pull it out and remove the fuse from the board.
3. Push in the new fuse, and turn it 90 degrees to the right to install.

Fuse2 (Machine valves: 1A)      Fuse1 (E-Stop: 315 mA)

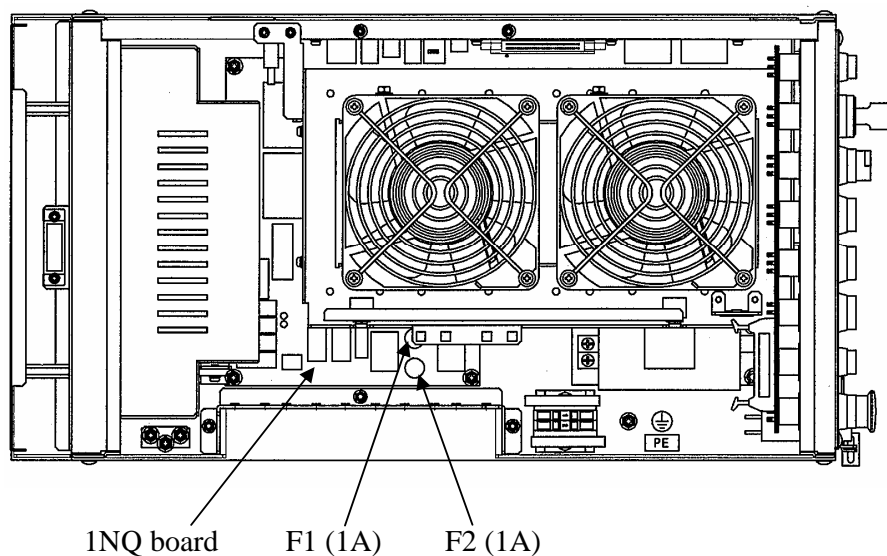
### 2.9.2 FUSES ON 1NQ BOARD (FOR D7X CONTROLLER)

1. Turn OFF the control power.
2. Remove the controller cover.
3. Turn the fuse 90 degrees to the left. Then pull it out and remove the fuse from the board.
4. Push in the new fuse, and turn it 90 degrees to the right to install.
5. Restore the controller cover.

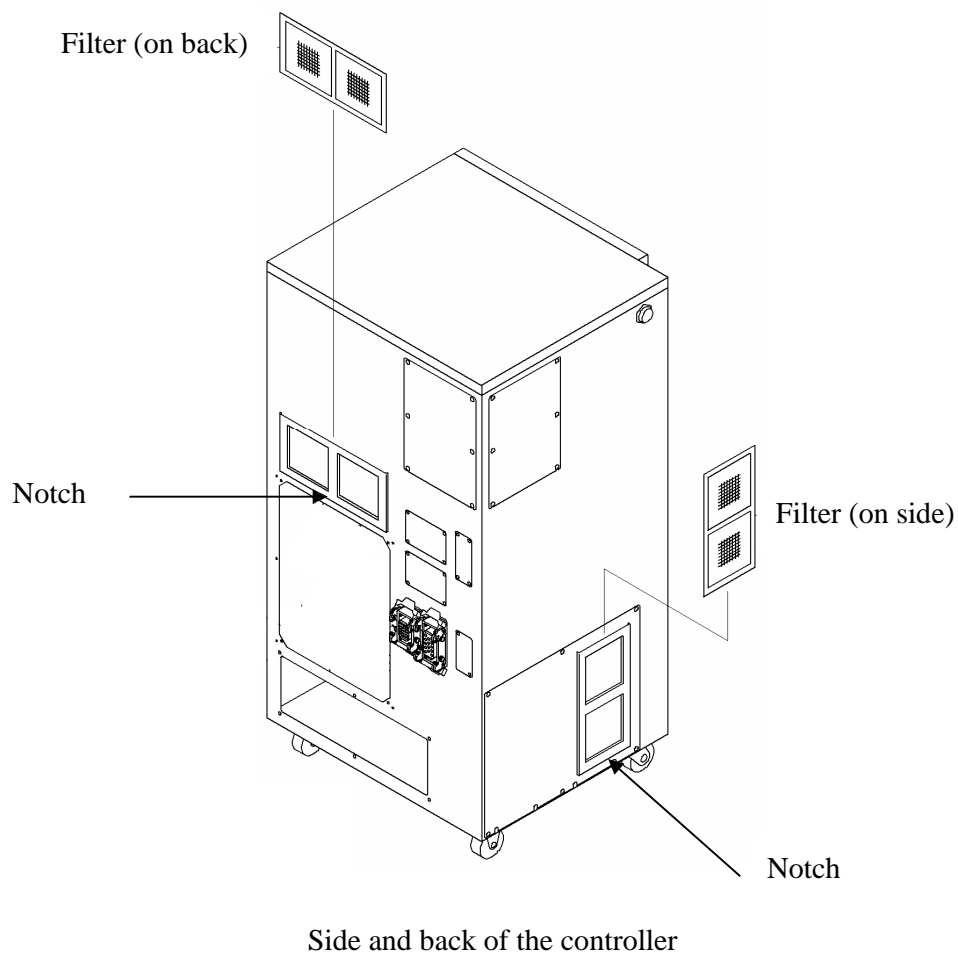
## 2.10 REPLACEMENT PROCEDURE FOR FILTER

Filters are located on the side and back of the controller. Take the same procedure to replace these filters.

1. In the center, bottom of the holder for the filter there is a notch. Insert something tube shaped into the notch, and push up the filter. Be careful not to damage the controller face.
2. Pull up the raised filter.
3. Insert the replacement filter into the holder.
